POST-REMEDIATION VERIFICATION REPORT

Client Name: Jordan & Taylor Sample
Property Address: 1450 Demonstration Way, Boca Raton, Florida 33496
Date of Inspection: April 14, 2026 (post-remediation verification and clearance sampling)
Report Date: April 14, 2026
Inspected By: Christopher Finnegan
Florida Mold Assessor License #: MRSA 3454
SAMPLE REPORT — All names, addresses and laboratory values are fictional.

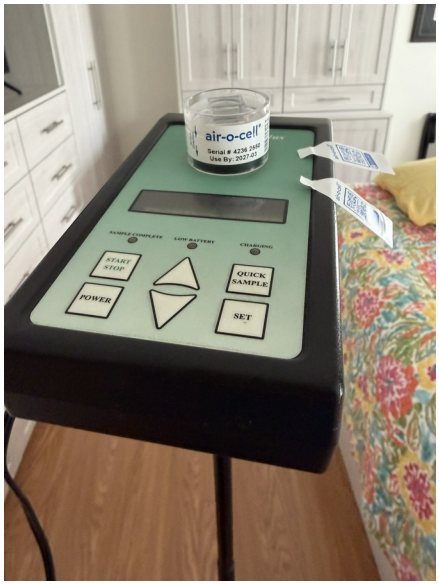
Photo 1: Representative: clearance air sampling (Air-O-Cell cassette).

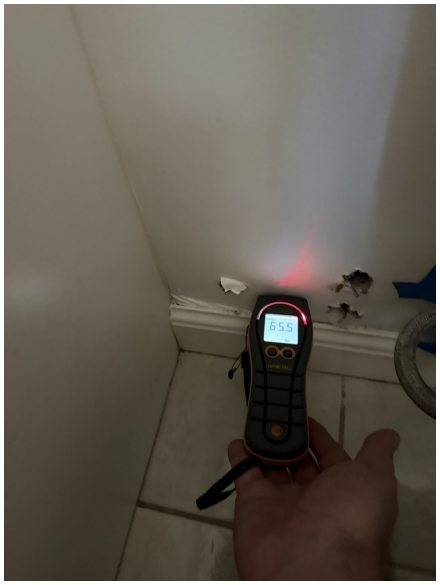
Location	Reading 04/14/26 (WME)	Dry Standard (WME)	Result
Living Room wall framing (former 50.6)	9.4	8 – 10	Dry
HVAC closet bottom plate	9.8	8 – 10	Dry
Primary Closet wall framing (former 56.5)	9.0	8 – 10	Dry
Hall and Bedroom 2 wall base (former 20–22)	9.6	8 – 10	Dry
Unaffected reference, Great Room	9.1	—	Reference

Photo 2: Representative: moisture verification of the exposed substrate.

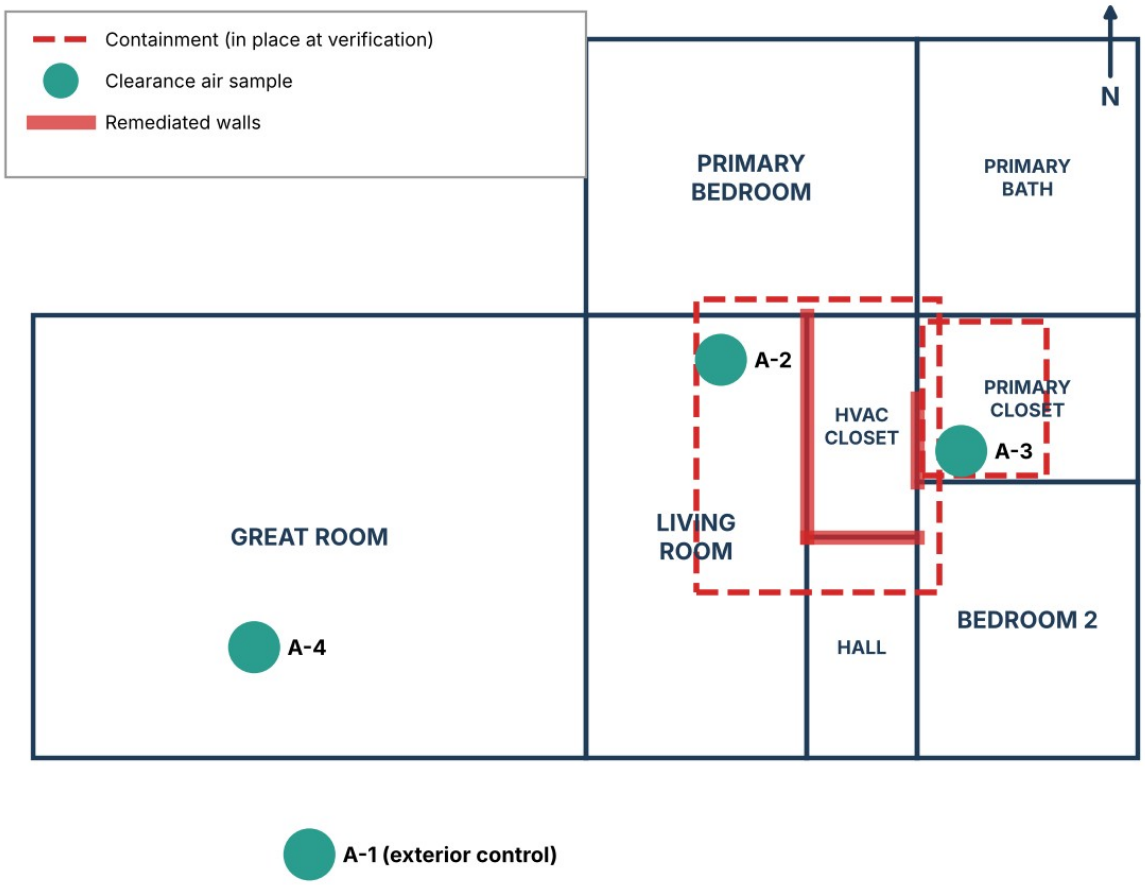
- Exterior control, rear patio — Sample A-1
- Living Room / HVAC closet containment — Sample A-2
- Primary Closet containment — Sample A-3
- Great Room, outside containment — Sample A-4

SAMPLE — Clearance Sampling Locations (not to scale). First floor, 1450 Demonstration Way.
