MOLD ASSESSMENT REPORT

Client Name: Jordan & Taylor Sample
Property Address: 1450 Demonstration Way, Boca Raton, Florida 33496
Date(s) of Inspection: March 10, 2026
Report Date: March 11, 2026
Inspected By: Christopher Finnegan
Florida Mold Assessor License #: MRSA 3454

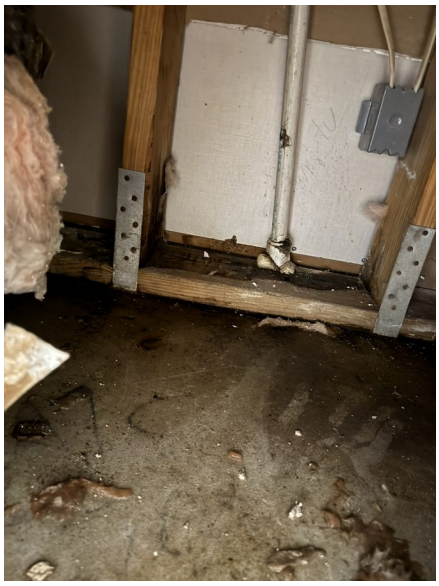
The lower front panel of the air handler platform had been removed and openings had been cut at the base of the closet walls before this inspection. Through the openings, the bottom plate and lower framing were stained, fiberglass insulation in the cavity was wet and collapsed, and debris and staining were present on the slab. Surface sample S-2 was collected from the cavity behind the platform.

Photo 4: HVAC closet — opening cut at base of wall (by others).

Photo 5: HVAC closet cavity — staining at bottom plate; debris on slab.

Photo 6: HVAC closet cavity — wet, collapsed insulation.

Photo 7: HVAC closet cavity — water-stained insulation.

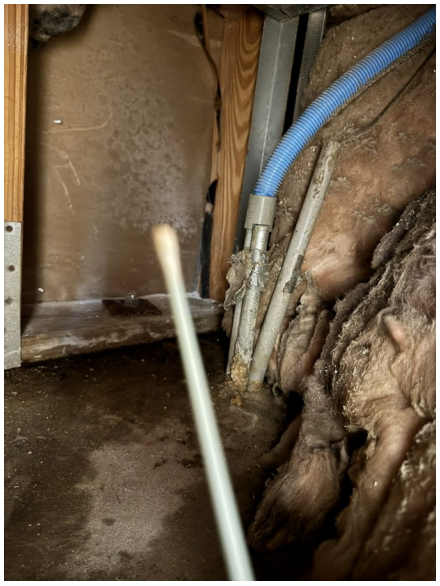
The baseboard and the lower edge of the gypsum board at the Living Room wall shared with the HVAC closet were damaged and discolored, and the paper face of the gypsum board was delaminating at the base. Surface sample S-1 was collected at this location. The engineered wood flooring in the Living Room and Great Room was cupped along board seams. Air sample A-2 was collected in the Living Room and A-3 in the Great Room. Infrared imaging showed cooler patterns at the lower wall consistent with the moisture readings (Appendix B).

HVAC closet cavity (S-2): Aspergillus/Penicillium-like 18,240 spores per square centimeter (raw count 228), 100 percent. Hyphal fragments 880 (11). Reporting limit 80 spores per square centimeter.

Photo 8: Surface sample S-2, HVAC closet cavity.

Photo 9: Living Room — damaged baseboard and gypsum board at shared wall.

Photo 10: Surface sample S-1, base of Living Room wall.

Photo 11: Hall adjoining the HVAC closet.

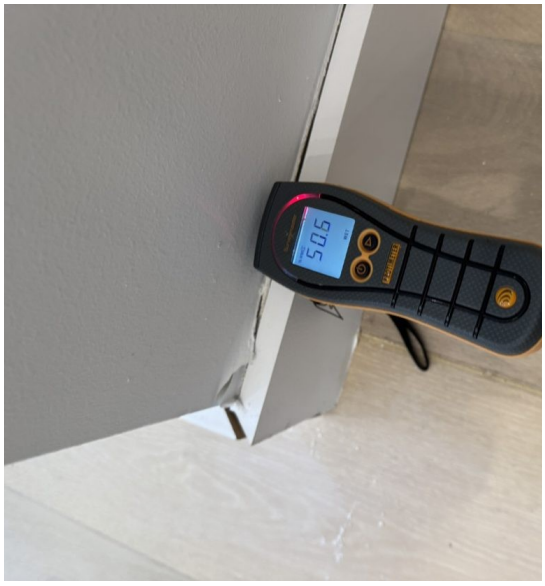
Photo 12: Moisture reading 50.6 WME — Living Room wall base.

Photo 13: Moisture reading 56.5 WME — Primary Closet wall.

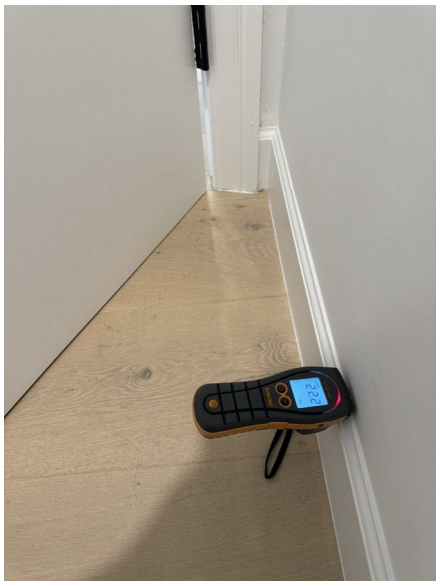
Photo 14: Moisture reading 22.2 WME — hall wall base.

Photo 15: Moisture reading 20.3 WME — Bedroom 2 wall base.
